MOUNT HIGBY RESERVOIR DAM  
CT. 00140

PHASE I INSPECTION REPORT  
NATIONAL DAM INSPECTION PROGRAM

FEBRUARY, 1979

Identification No: CT 00140  
Name of Dam: Mount Higby Reservoir Dam  
Town: Middletown  
County and State: Middlesex County, Connecticut  
Stream: Fall Brook  
Date of Inspection: 8 November 1978

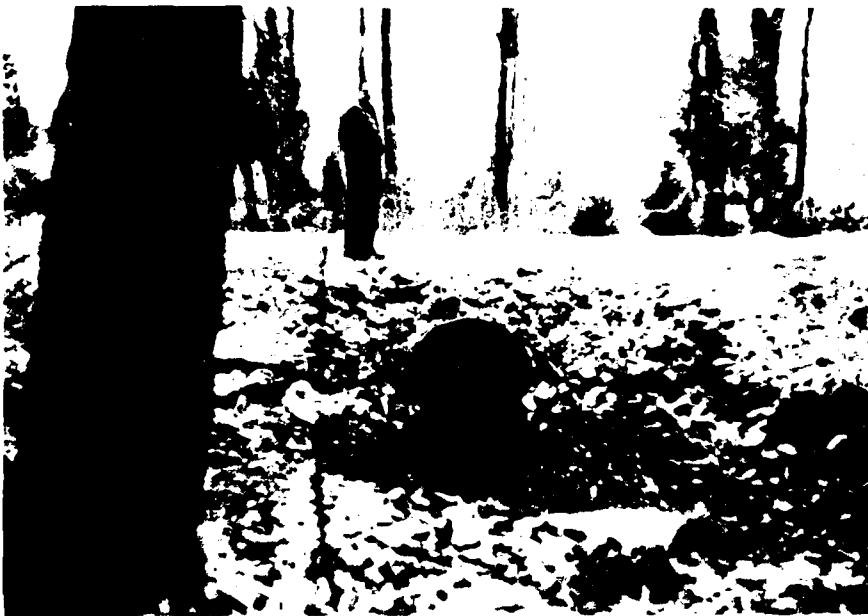
2. Outlet channel culvert under trail below dam.
